Analysis, Protection and Preservation of Medieval Wallpaintings.

A Raphael-Project financed by the European commission is developing innovative preservation strategies combined with an extensive information network.

Analysis, Protection, and Preservation of Medieval Wallpaintings

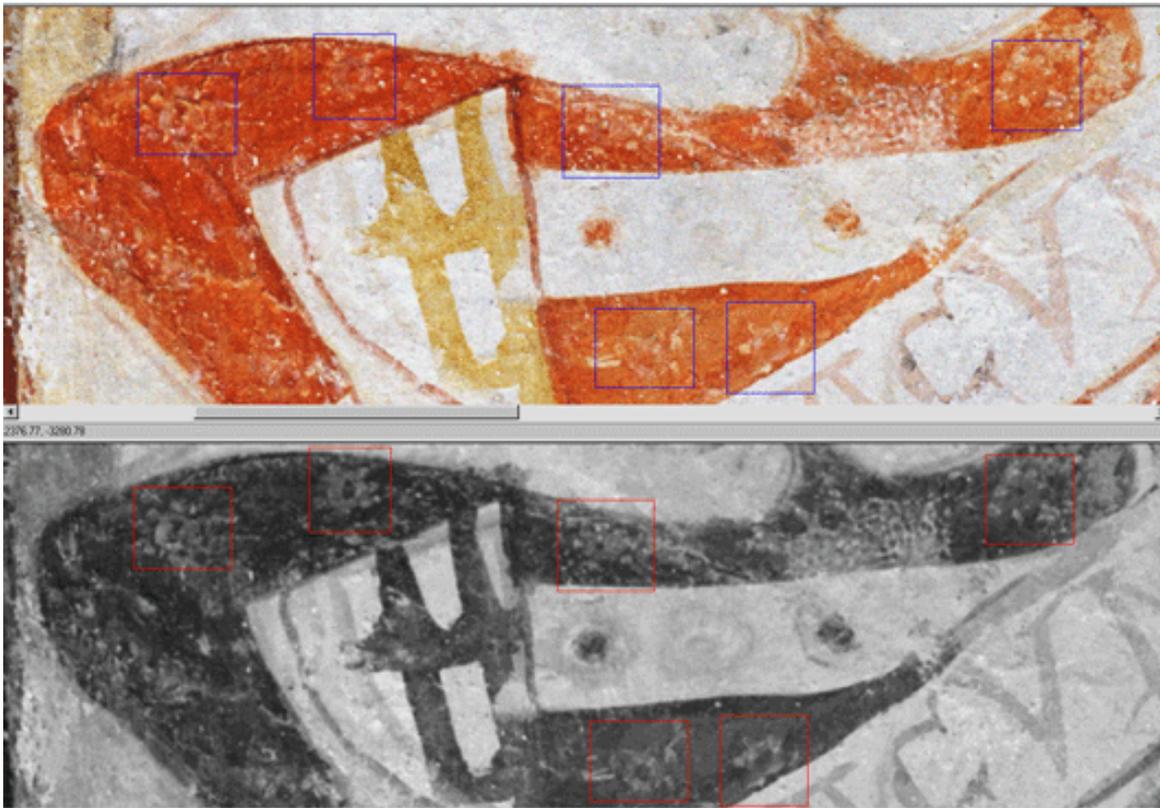
examination of the UV- band leads to a much better visualisation and a precise localisation in unexpected areas.

Visualisation of a special decoration technique in a colour image and the UV Band

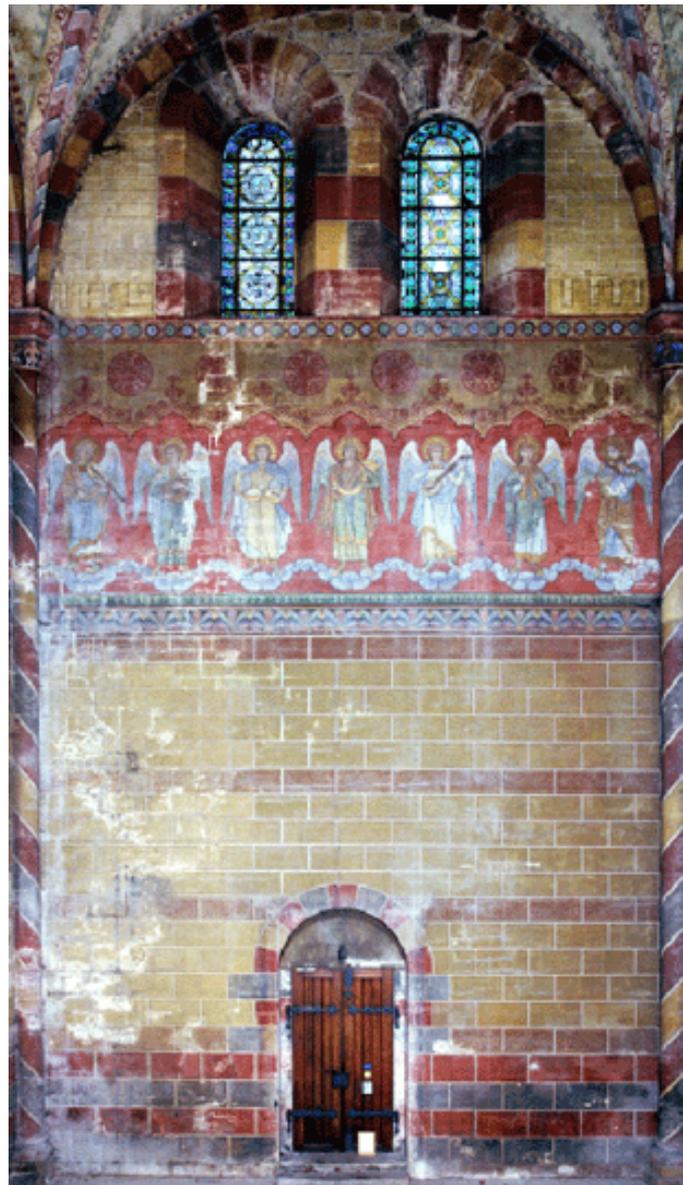
Image map of the north wall in the northern transept of the Kaiserdom, taken in 1994

The wall is contaminated by cement, which was poured into the space between the facade and inner wall during a treatment in the 1970s attempting to stabilise the fabric. The cement suspension has spread through the drilling holes and is visible on the surface in the form of grey running drips. Multi-spectral bands taken in 1998 show this phenomenon very clearly.

Within the framework of the Raphael Project an area from the wall with this damage was chosen for the multi-spectral photography for the purpose of isolating this phenomenon.

Because the cement has specific spectral characteristics, extraction was possible by statistical methods, which allow for the isolation of all pixels with the same properties. This resulted in a thematic map of the cement damage.

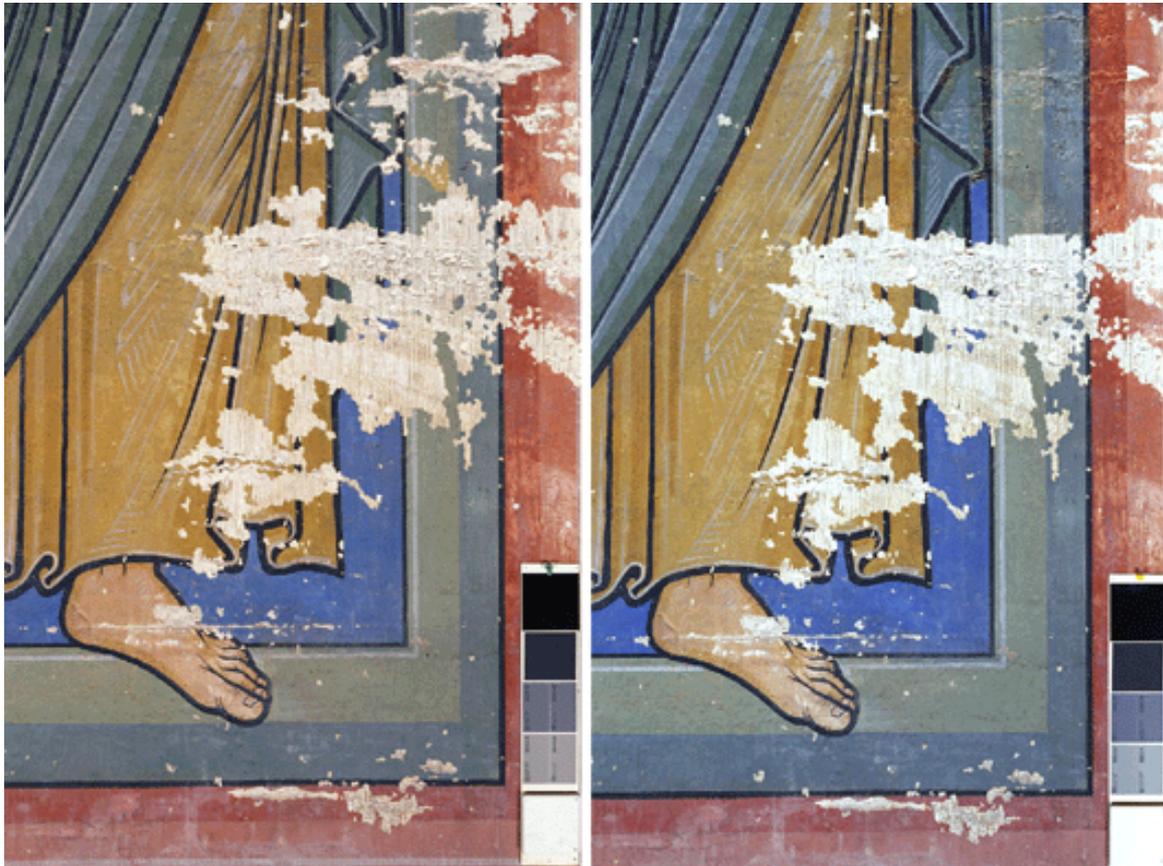
In order to compare the condition of the wall painting in the two monitoring phases a first attempt was carried out by computing a different image based on the colour slides, on the example of a wall painting located on a pillar in the crossing of the transept.

Condition of the wall painting in winter (left), and summer (right)

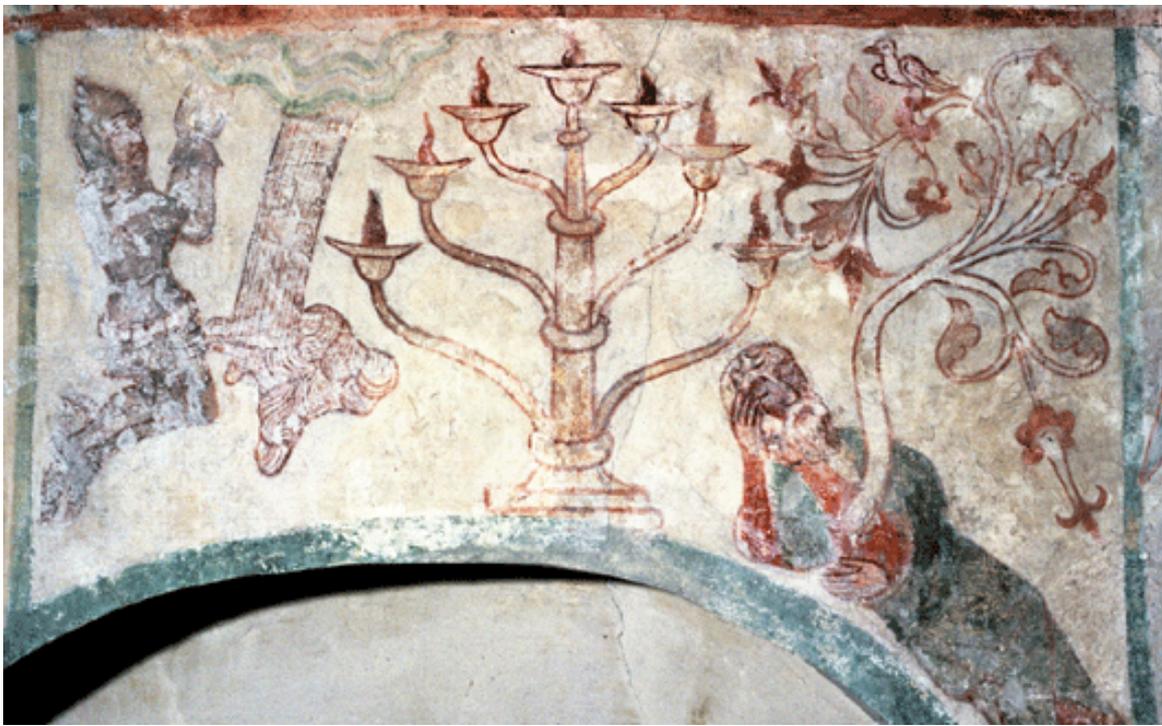
Condition of the painting before treatment (Dec. 1999)

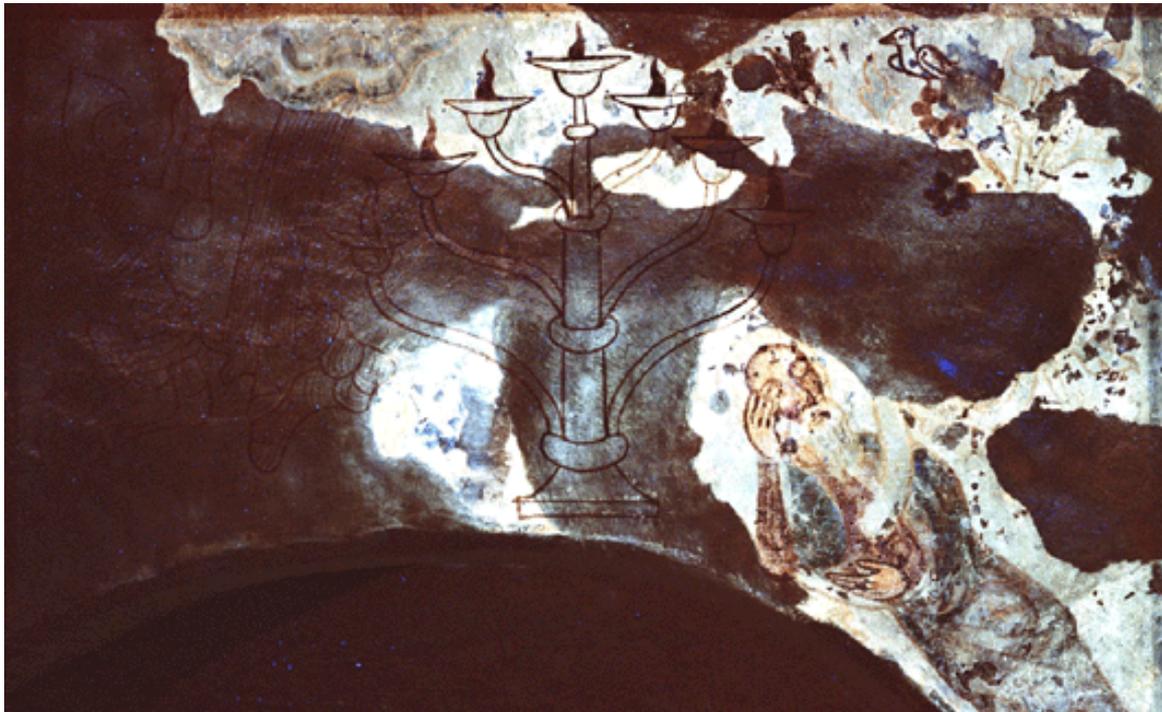
The UV fluorescence image taken after the treatment clearly shows the reconstructed parts of the pictorial image. The plaster repairs are the dark areas, while the original materials are seen with a high reflection value.

UV fluorescence image taken on Aug. 20, 2000

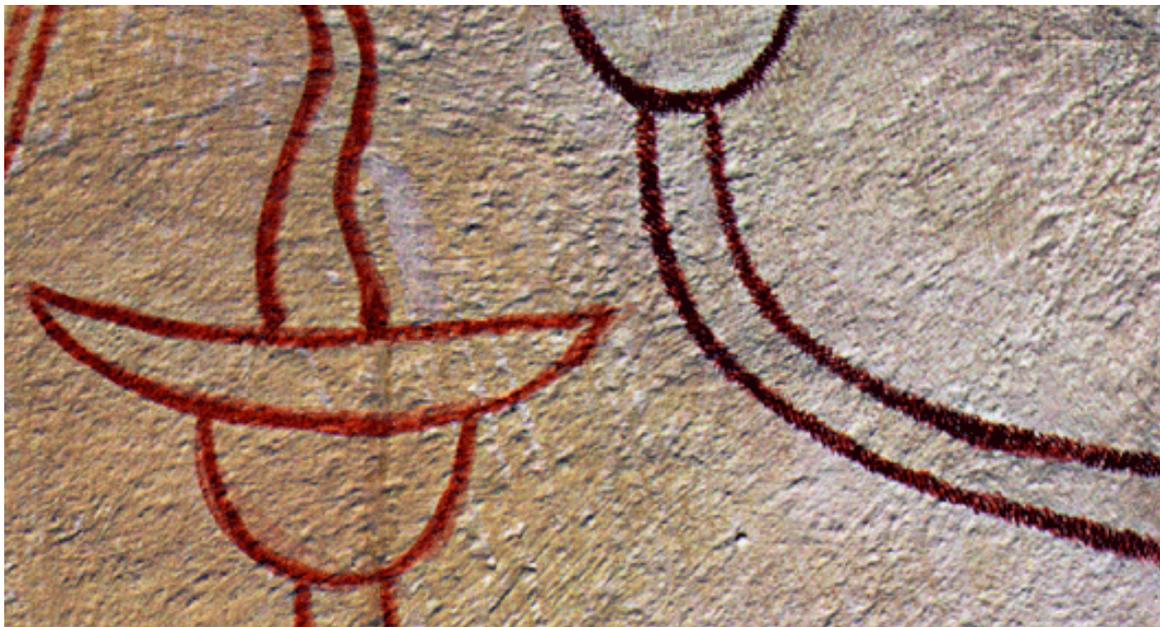
This image shows the two line types used for reconstruction: solid (left) and hatched (right)

The classification of the two line types was possible by examining minute areas containing line ends. If such an area contained several line ends, it was classified as the hatched type and depicted with a black colour. The purple colour denotes the solid lines.

Utilising image processing methods which can isolate parts of the image dependant on the structure may produce better results. This was initially attempted by applying the software “Ecognition” by Definiens (Munich) to detect the two techniques that were used by the conservators for replacing lost pictorial content: solid monochromatic lines and hatched monochromatic lines.

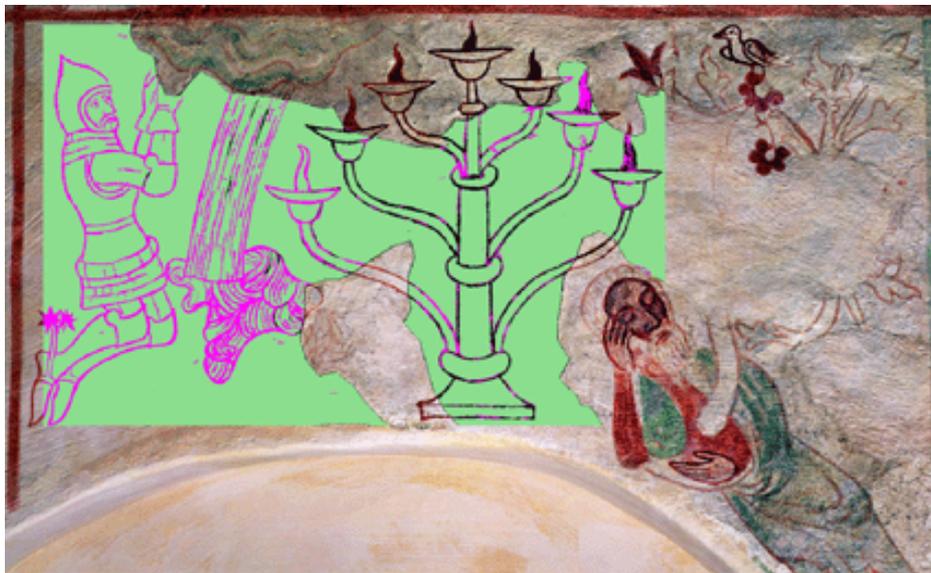
Classification of the two line types was carried out on a selected area (green field). The image shows a first attempt, with a correct classification result of about 70%. A better result would require further modification of the definition of the search mask

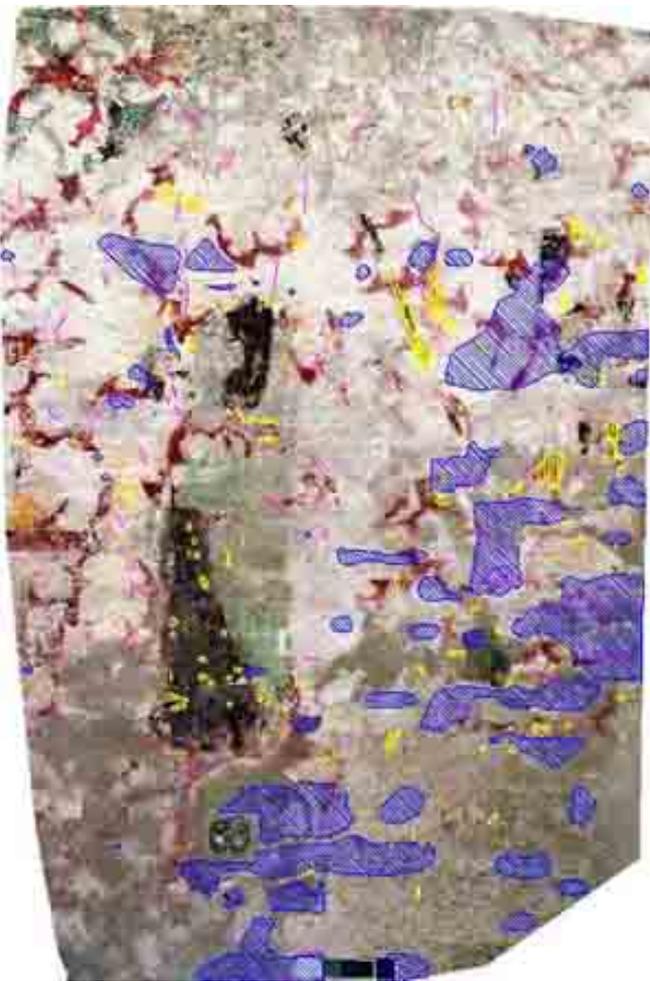
*Germany, Königslutter Stiftskirche.
Medieval wall painting in the lower storey
of the westwork, detail of the tree of jesse.
Original AutoCAD-mapping of damage
phenomena on the base of a rectified color
image. Foto: Deutsches Bergbau-Museum
Bochum*

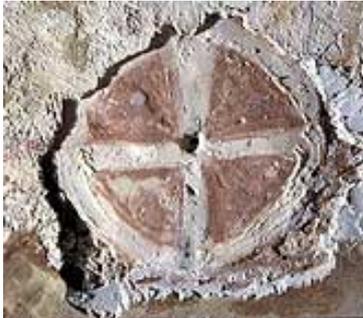
In the 13th century the interior of Tirsted Church was decorated very simply. Mortar was applied only in the areas where a series of round consecration crosses were painted. The circumference of the circles was incised in the fresh plaster with the help of a compass, the point of which sank deeply in the centre. The circle (ca 20 cm in diameter) was divided into quarters by a bold white line, about 2 cm wide, and the four fields formed by this division were painted with a red-ochre colour. Finally, a wide white line was painted around the circumference. The paint was applied very quickly, and the impasto of the white paint indicates that a slaked lime putty was used.

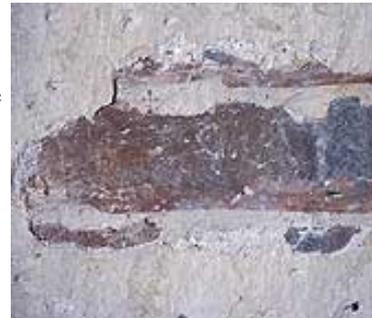
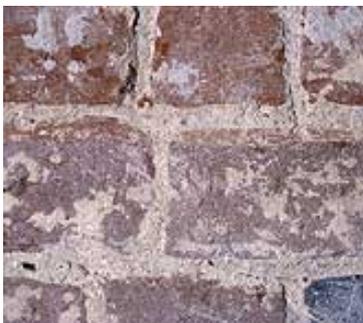
The remaining surface in the interior consisted of red bricks. The bricks were laid with one header alternating with two faces, forming a pattern where the headers were lined up vertically, forming the so-called monk's bond. Recent investigation of the original brickwork has revealed that a layer of red paint was applied to the bricks, leaving the white mortar of the joints uncovered.

It was not possible to determine whether this practice was confined only to the slightly discoloured and deformed bricks, or whether all the bricks were painted. In any case, it seems that the appearance of neat brickwork was important, and that in the least, corners and edges were retouched so that they would appear to be straight and sharp.

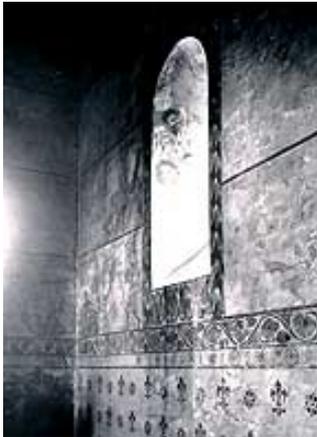
A photograph of the south-east part of the chancel from 1917 shows what poor condition the wall paintings were in a mere 25 years after their uncovering and restoration. The damage is clearly connected to problems with moisture in the plaster layer. Numerous light and dark-coloured stains had formed on the surface of the plaster. The damage generally follows the joints of the underlying bricks, and therefore can be assumed to be a result of the transport of water-soluble salts through the joint mortar. The stains forming on the interior surface were probably also a result of the presence of various salt ions, which were transported in the porous substrate.

In 1927 the wall paintings restorer employed by the National Museum, Egmont Lind, inspected the paintings on the chancel walls, the condition of which he described as “mildly stated – horrible”. He concluded that the salt damage was caused by the radiators that were heating the interior. The first re-restoration began the 15th of February 1929 and continued over four months, ending the 9th of July. It was mostly carried out by Egmont Lind, with the participation of Eigil Rothe to a lesser degree.

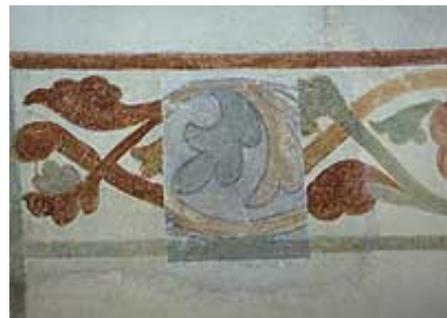
Lind does not reveal details of the treatment, stating only that the scenes were dusted off, and impregnated with Carlsberg Preparation (an as of yet unidentified concoction prepared by the Carlsberg Brewery for the treatment of wall paintings in Denmark). He was, however, quite critical of Kornerup’s reconstructions, which he considered to be based “to a high degree on free fantasy.” Other reconstructions were “carried out with little connection to a medieval painting style.” Kornerup’s report from 1929 concentrates on the artistic changes he made to the painting so that would more closely resemble a Gothic painting. The difference in the painting styles of Kornerup and Lind can be seen on a fragment where Lind’s reconstruction was partially removed to reveal the reconstruction of Kornerup underneath.

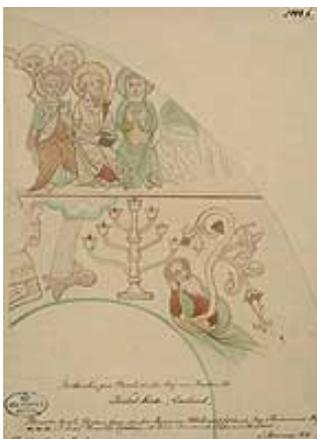
Another example of changes made in the reconstructed areas can be seen on the kneeling figure of Gideon, depicted as a knight in armour, which was partially destroyed by the insertion of a window in the south wall after the vaults were built.

We can only see about half of the figure on Kornerup’s watercolour from 1876. The part that is visible is documented as dark lines on a light background, and a photograph from 1917 shows that this is the way Kornerup reconstructed this figure. However, Lind chose to repaint the figure, changing the armour to black, and making the outlines white. On the same scene, the sleeping figure of Esai is seen with the Tree of Jesse growing out of his chest. Lind not only moved the sprouting branch from the right side of the chest to the middle, but he also added many new branches and flowers. In addition, Lind changed the beard and hair on the sleeping figure, and many other details, such as the clouds depicting heaven, and the water falling from the sky. In effect, Lind’s additions were more often than not a result of his fantasy, despite the fact that this was his strongest criticism against Kornerup’s restoration.

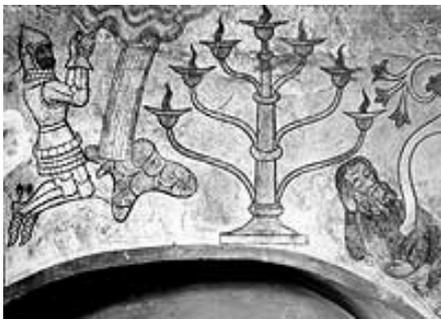
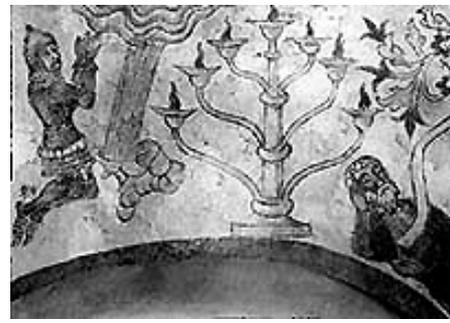
An interesting detail affecting both Kornerup's and Lind's restoration reflects the prevailing moral attitudes at the end of the 19th and beginning of the 20th centuries. In the scene depicting the meeting of Mary and Elisabeth, both of the pregnant women were painting with an opening in their stomachs showing the tiny figures of Christ the Child and St. John the Baptist. The display of such corporal details was unacceptable when Kornerup uncovered the paintings, and the wombs on both figures were covered over with gypsum and their dresses were painted on top. Lind removed the gypsum despite the fact that "the exposition of the embryos strongly shocked the moral opinion of the priest and some of the members of the parochial church council."

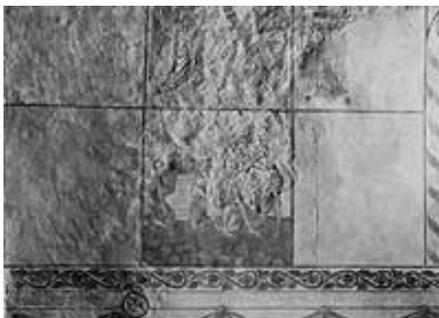
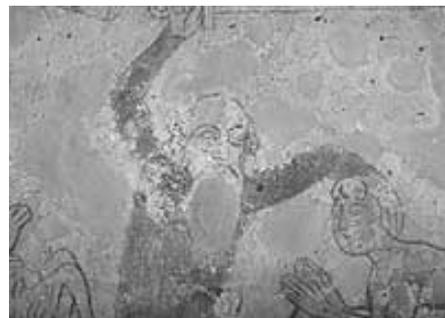
The impregnation of certain areas with the Carlsberg Preparation, however, was not the only reason for the appearance of salts in the adjacent areas. Lind and Rothe retained most of the mortar repairs that were carried out during Kornerup's restoration in 1891-2. There where Lind found Kornerup's reconstructions unacceptable, he simply washed off the paint layer, and reused the same surface for his own reconstructions. The mortar that was used for these repairs was very hard and had a smooth and closed surface (something that can be very clearly seen on photographs taken with raking light). It was, therefore, easier for the salts to migrate to the surrounding original areas that were more porous.

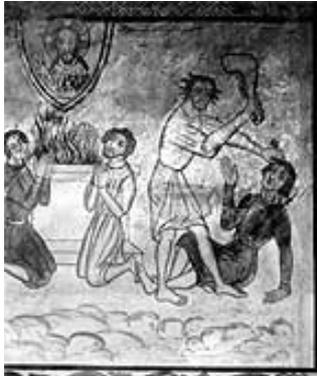
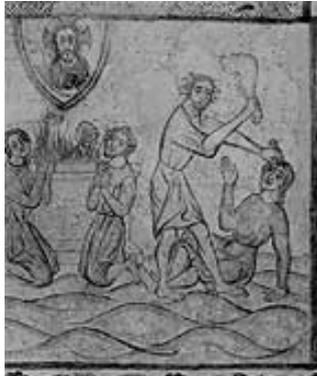
Lind remarks that the scenes that were not impregnated in 1929 because of their good condition were now in such poor condition that there was almost nothing left of them. He attributes this to the lack of impregnation, and not to the fact that the untreated areas were more porous than the treated ones, which led to a migration of the moisture and salts to the untreated scenes. Only two scenes on the south wall, Esther and Ahasverus and the Pentecost scene are described by Lind to be in good condition. Because he considers the deterioration of the paintings to be inevitable, ending in the total loss of the entire decoration, Lind suggests that, at least, the Esther and Ahasverus scene could be detached in the near future. "(The church community) has accepted the fact that the day will come when the rendering (and paintings) must be knocked off the wall...Whether a new rendering should be applied, or whether the red bricks should be displayed is a discussion in itself – the latter would probably be the most beautiful. In the meanwhile, the church can start to collect funds to pay for a couple of stained glass windows in the east wall, or a granite or brick altar to replace the existing altar, which, one must say, is a foul piece of carpentry, so that (this way) the pain over the loss of the wall paintings will quickly wear off."

The re-restoration of the paintings in 1940 centred mostly on the consolidation of the plaster (possibly with polyvinyl acetate), the execution of some new plaster repairs, and a renewal of some of the reconstructed portions of the painting. These reconstructions were not necessarily a repetition of the areas supplemented in the previous restoration by Kornerup, or even a repetition of Lind's own reconstructions from 1929. The changes in the iconographic details can be traced on archive photographs. For example, Kornerup reconstructed the lower portion of the Cain and Abel scene, painting some irregularly-shaped stones in 1892. In the course of the first re-restoration in 1929, Lind changed the stones to a series of wavy lines. In 1940 Lind redid this portion of the scene, changing the lines back into stones. However, he did not use Kornerup's stones as a model. A close inspection of the decorative border under the scene also shows that it was redone by Lind.

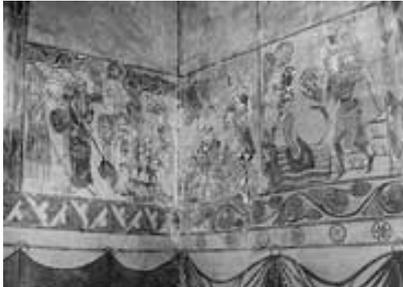
The detachment of three scenes in 1973-74

A photograph taken in 1973 of the south-east corner of the chancel clearly shows the poor condition of the wall paintings prior to their detachment in the last months of that year. The damage was concentrated in the areas where the original rendering was still intact. Not much was left of the scene depicting Jonas and the Whale and Samson Bearing the Gate of Gaza. The lower half of the scene was a complete reconstruction executed by Egmont Lind in 1929 on the same hard and smooth plaster Kornerup used for his reconstruction (Lind removed Kornerup's reconstruction but re-used the plaster).

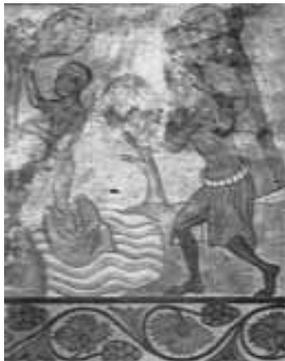
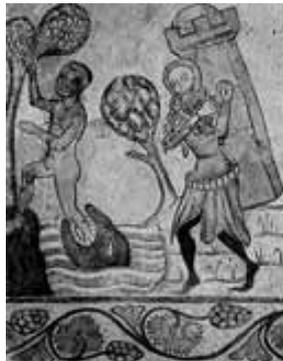
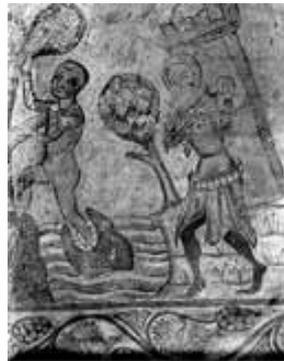
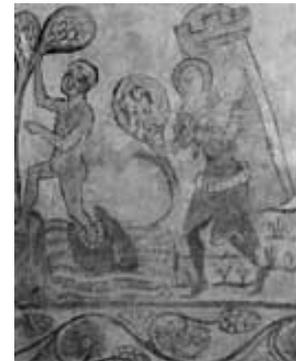
The upper half was restored by Kornerup, and re-restored twice by Lind, and small details were altered every time the painting was treated. The three scenes were not retouched before they were detached, and afterwards the surviving lines were enhanced by overpainting, but the lost details, such as the hair and the features on the face, or the leaves on the trees were not reconstructed. The deterioration of the pictorial content can be traced on a series of photographs spanning 76 years: 1917; 1929; 1940; 1973; 1974

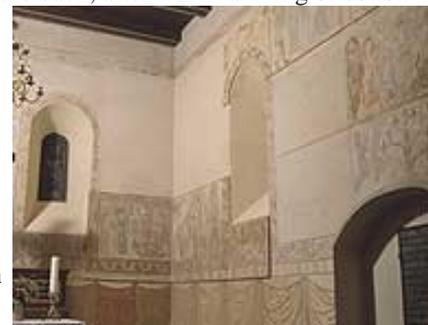
The surface treatment of the paint layer prior to the application of the facing consisted of spraying with a commercial fixative (more specific information was not provided). Cotton gauze was cut in squares measuring 20 x 20 cm and glued to the surface with animal glue. Four layers were applied. Afterwards, each scene was cut along its borders, and then each was detached from the wall separately. All the rendering that detached together with the paint layer was then removed from the back by grinding it away with a Carborundum stone. A backing layer of titanium dioxide and polyvinyl acetate emulsion was spread on the back, after which a lining of cotton gauze was glued with polyvinyl acetate emulsion. Thus treated, the detached pieces were then glued with polyvinyl acetate emulsion directly to a oil-impregnated chipboard, and the facing was removed with warm water. The back of the plates were protected against moisture by a layer of aluminium foil, which was glued on. The edges of the plates on the scenes adjacent to each other were provided with tongue and groove fittings, so that the three scenes (and a piece of the decorative frieze) could be mounted together to form a continuous surface. The transfers were screwed back in their original locations with raw plugs and brass screws (through the front of the painting), with no space left for air circulation behind the plates. Finally, the heads of the screws and the joints between the plates were covered with putty (content not recorded) and retouched.

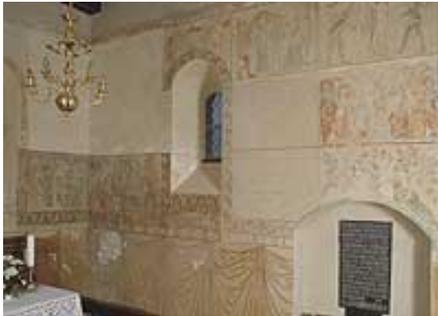
The re-restoration of two scenes in 1994

New problems with salt crystallisation appeared within five years after the transfers were hung in the upper register on the south wall. The surface of the wall blocked by the plates did not allow the transpiration of moisture, so instead, the salts crystallised around the transfers. A similar situation was occurring on the lower transfers hanging in the south-east corner of the chancel.

Again, the purpose of the treatment was to prevent the execution of additional detachments. Because the effect of new salt crystallisation was discerned in the original plaster around the various plaster repairs that stemmed from the previous treatments, an attempt was made to prolong the life of the two scenes on the wall by removing all of the older plaster repairs. They were replaced by a weaker mortar made with slaked lime and sand, the surface of which was cut with a spatula to create an open and toothed surface with a larger area in order to facilitate the transport of moisture and salts.

The new repairs were covered with limewash, which was toned to match the warm-coloured background of the paintings, and retouching was carried to the level of the colour strength of the surviving paint layer surrounding the lacuna. In effect, however, the newest plaster repairs were supposed to function as sacrificial layers, which would hopefully attract moisture migrations and salt crystallisation. This was a temporary solution, because it was now becoming more and more apparent that a major re-restoration of the entire decoration in the chancel was inevitable. But despite this prospect looming in the close future, the attitude in 1994 was that of let's-see-if-this-helps-a-bit. This attitude was a result of several factors, one of which was the feeling of guilt and compassion on the part of the conservators towards the small rural church community in Tirsted, who were repeatedly being subjected to treatment after treatment and bearing the financial burden for all the work carried out inside the church, as well as the frequent repairs of the drain outside. Already nine years earlier Kirsten Trampedach was sensitive to the situation: "As the paintings on the south wall, despite repeated conservation treatments, were not able to be preserved, it would be reasonable

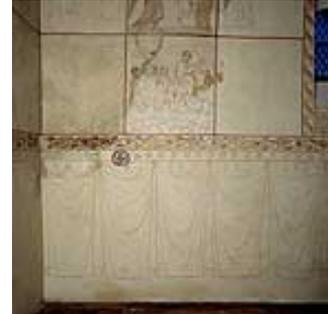
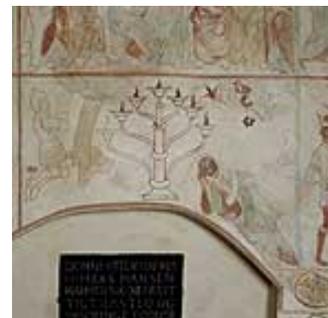
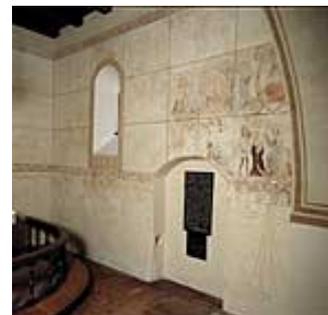
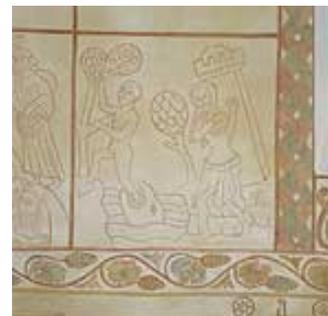
The work started with the removal of the old plaster repairs, which were both physically and aesthetically damaging to the surrounding areas, and the cleaning of the decoration. A limited amount of consolidation of the plaster and paint layer was necessary. New plaster repairs were carried out with a lime and sand mortar that followed the configuration of the uneven surface. This was followed by a salt reduction of the salt-contaminated areas where the original rendering still existed (the west wall and the west part of the north wall, where no salt damage was visible, were not treated). The various phases in the treatment program were documented by mapping.

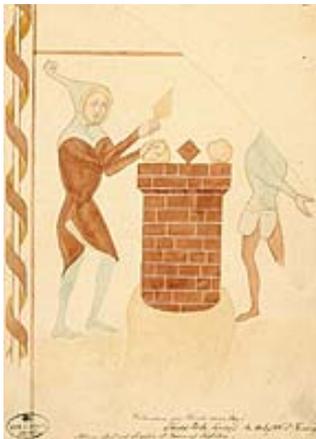
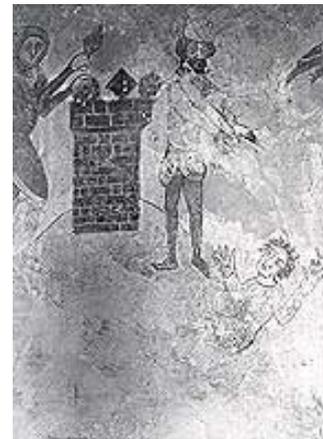
The first photograph of the scene is from 1917, and it shows three figures – two standing men, and only the upper half of a third man in the lower right side of the scene. Kornerup extended the torso of the third figure to the left, but did not reconstruct the legs. Egmont Lind, taking up Kornerup's hint that this was not a standing figure, reconstructed the lower half in 1940, drawing the legs in a manner that suggested that the figure was falling down the hill. However, during the re-restoration in 1999, it was discovered that the limewash layers were never removed from this area, and the damaged, but still visible, legs of the figure were found directly in line with the torso, indicating that this was a standing figure.

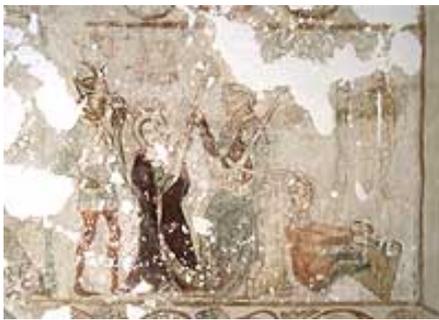
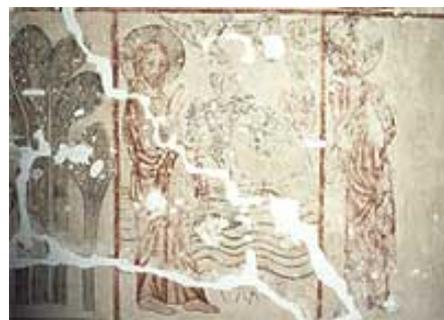
These lacunas in the paint layer not only created visual unrest, but also made it difficult to perceive some of the figures. The plaster repairs were prepared with a limewash layer that matched the general tone of the background. This formed the ground layer for the retouching, which was carried out with watercolours using a hatching technique.

After carrying out the plaster repairs and salt reduction treatment two types of aesthetic disturbances were prominent in the decoration. The first were the large areas, sometimes covering many square meters, where it was decided that the missing pictorial content would be reconstructed with a simple red line so that the iconographic content of the decoration would not be reduced. The second were the countless tiny repairs, often no larger than a thumbnail, as well as the small and medium-sized repairs that were located within the surviving scenes.

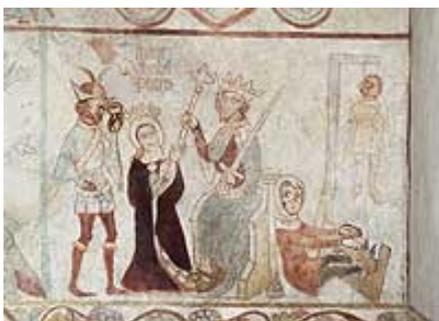
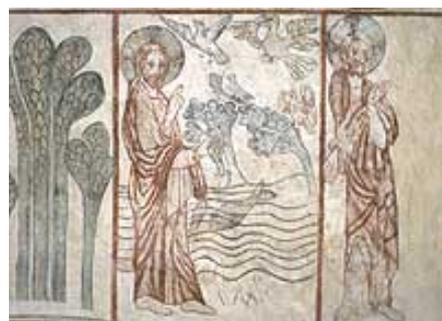
This technique was considered appropriate in this case due to the original textured surface, which was created by the crossing tracks of the bristles of the brush used to apply the limewash. Furthermore, by keeping the network formed by the cross-hatching lines open, it was easy to maintain a light and airy appearance of the retouched areas, which matched the worn appearance of the original paint layer.

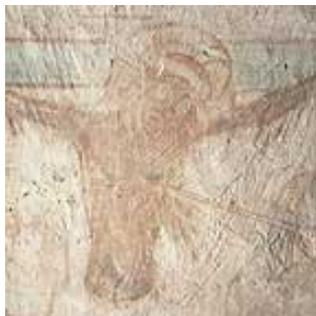
The paintings in the chancel were executed on a thin layer of plaster, which was applied to the brick wall. The thickness of the rendering varies from 1 – 10 mm, with the exception of certain areas, especially on top of the joints of the masonry, where it can be up to 30 mm thick. The plaster has a very characteristic uneven and rough surface, creating a layer of pronounced plasticity. The mortar was applied in portions having no connection to the composition of the painting, in fact, it could have been applied long before the paintings were executed. The edges of the portions of plaster, which slightly overlap the previously applied portions, are visible (in raking light) in many areas of the painting.

A layer of creme-coloured limewash was applied to the plaster with a coarse brush. The limewash was spread very quickly over surface leaving trails of brushstrokes in various directions, attesting to a haphazard application. The limewash constitutes the ground layer for the painting, but it is also visible over large portions of the painting in the form of a background.

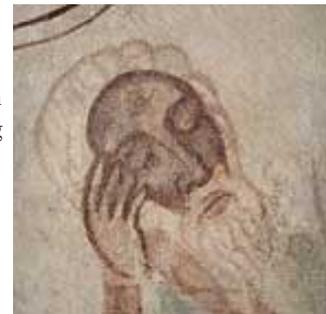
Fine lines incised in the ground layer have been found on almost all of the faces. Two parallel lines mark the bridge of the nose, and two lines define the eyebrows. These lines are so fine they cannot be seen from the level of the floor. They seem to have been executed as part of the drawing process, possibly as an aid indicating the placement of the features on the face. The lines are not present on the few faces where the final paint layers have survived, and a close inspection of these areas concluded that the scratched lines seem to be present under the paint layer.

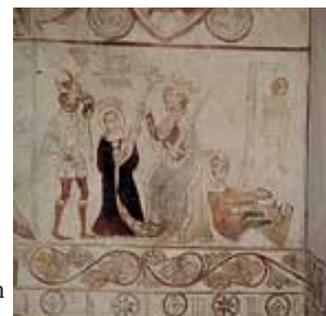
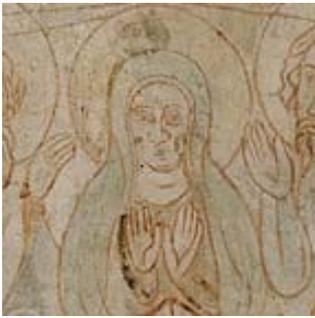
However, other colours were also used, albeit to a lesser degree. Some areas of the painting were outlined with black contours, on others a strong red oxide was used. The black spots on the cheeks of a figure are a result of decomposition of minium – a lead red. A similar effect is seen on the Crucifixion scene, where the blood painted with red lead is now black.

The red colour, ranging from pale or medium strength iron oxides to an intense violet caput mortuum, dominates the decoration today. Green has also been used, both in the ornaments and the garments of the figures. Two different shades of green are seen, but only the pale green – identified as basic copper chloride – belongs to the original painting. The darker and stronger green colour is an oxide of chromium, which was used in the restoration of the paintings. Yellow ochre was used in the scrollwork and within the scenes. These three colours – red, green and yellow – formed the main chromatic scheme of the decoration.

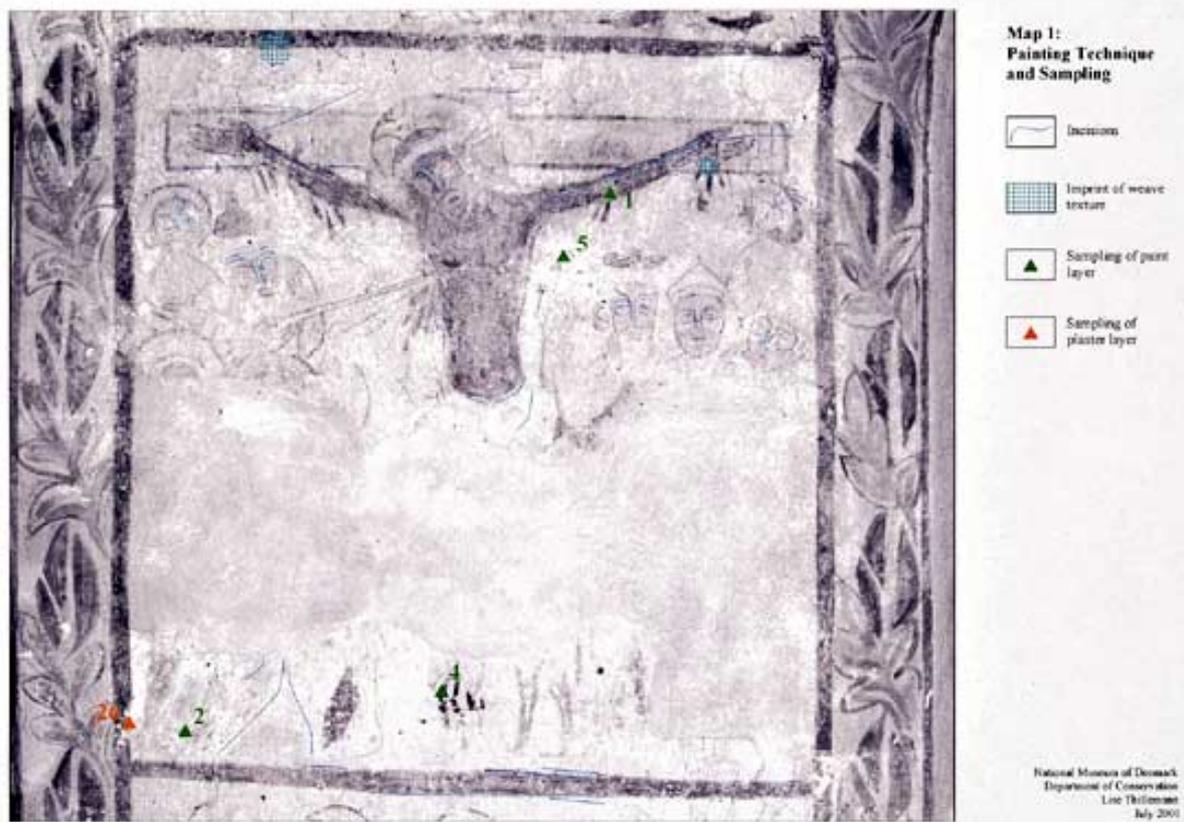
Tirsted Church, Chancel, East Wall: "Crucifixion"

An example of a map registering the painting technique is seen on Figure 1.

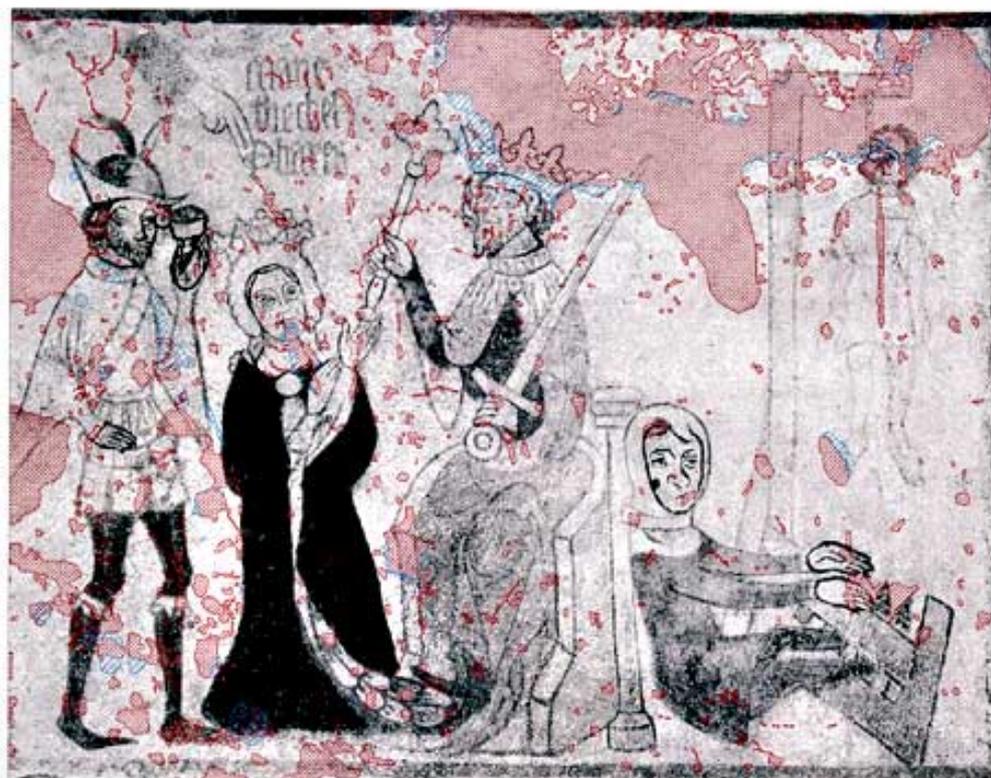
Tirsted Church, Chancel, South Wall: "Esther and King Ahasverus"

Map 5:
Treatment of
paint layer
Legend:
Uncovered areas
Retouching

- areas where the residual limewash was removed (2000_mat-pai_tre-unc) [2000_material-paint layer_treatment-uncovering]
- areas where the paint layer was consolidated with caboxy-methyl cellulose (2000_material-paint layer_tre-con-cel) [2000_material-paint layer_treatment-consolidation-cellulose based material]
- areas that were retouched (2000_mat-pai_tre-ret) [2000_material-paint layer_treatment-retouching]
- areas where the pictorial content was reconstructed on a new plaster layer (2000_mat-pai_tre-rec) [2000_material-paint layer_reconstruction]

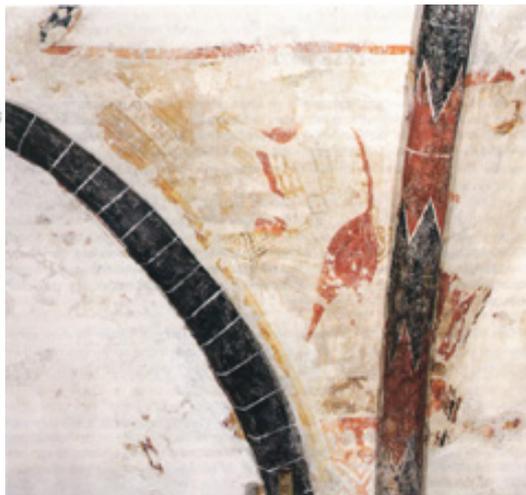
Drawing (4A) and photograph (4B) : Isaac

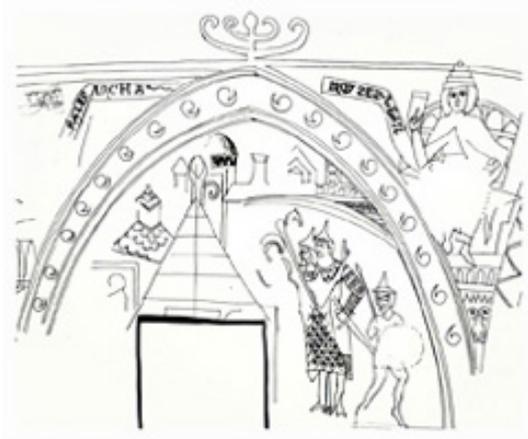
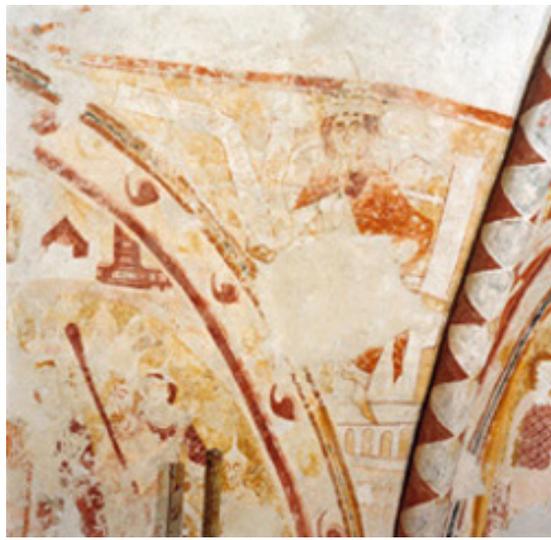
Drawing (5A) and photograph (5B): the Betrayal of Judas; Mozes

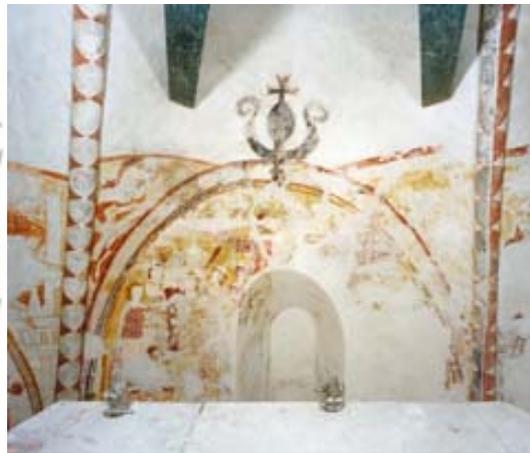
Drawing (6A) and photograph (6B): the Crowning with Thorns; Aäron and Salomon

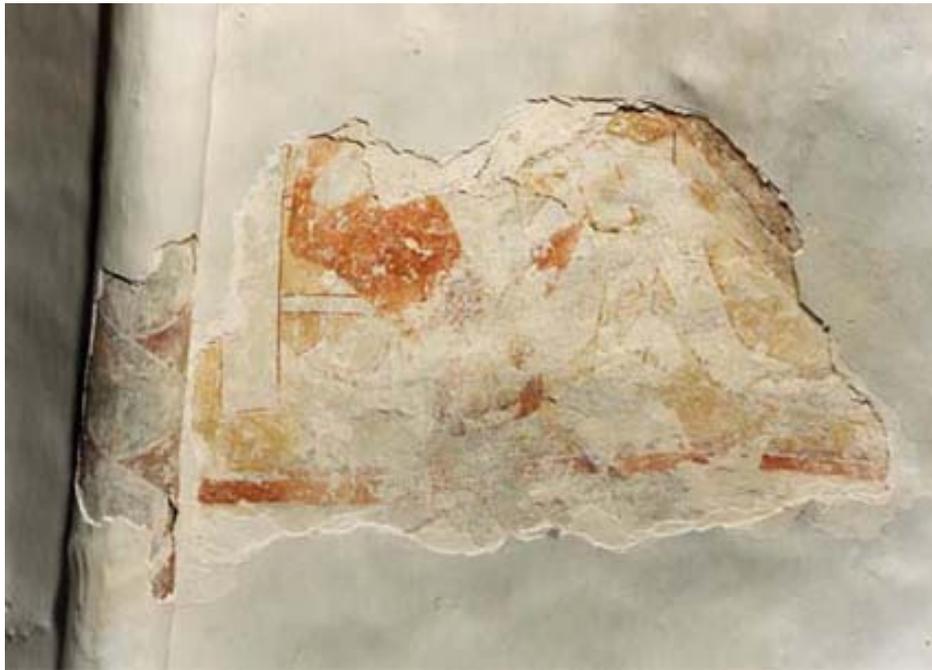
Photograph 11: Mozes, partly uncovered, with a thick package of lime wash layers around.

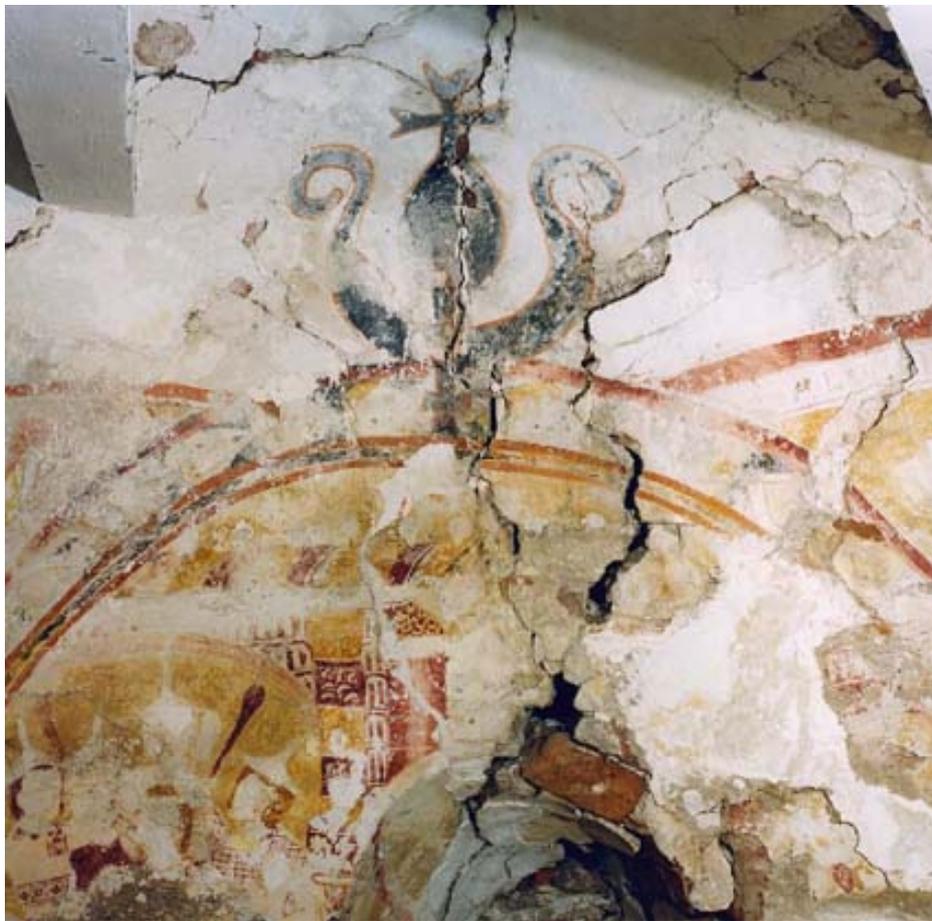
Photograph 12: the Crowning with Thorns and the damage of the wall around (before restoration).

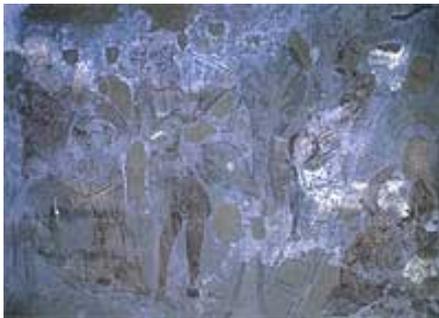
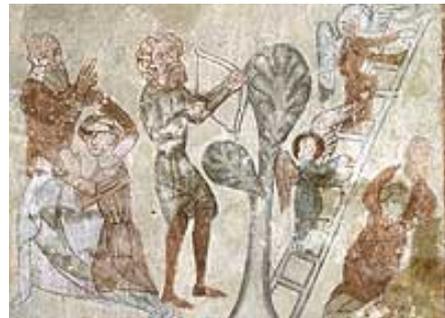
Only one of the seven samples sent to laboratory (Department of Conservation at the National Museum) for chemical analysis was positive for the presence of organic binding medium. This site, however, did not display any fluorescence in UV light. Visual examination determined that the sample belonged to an overpainting from an earlier restoration. There were many areas where a faint pink fluorescence was observed. Many of these areas were located on the faces and hands of the figures, but similar fluorescence was also seen on other parts of the scenes, such as the clothing. Organic binding media, however, was not found in any of the samples taken from these areas.

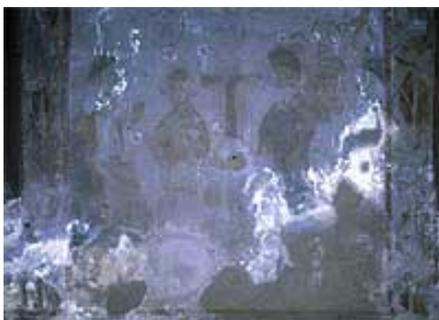
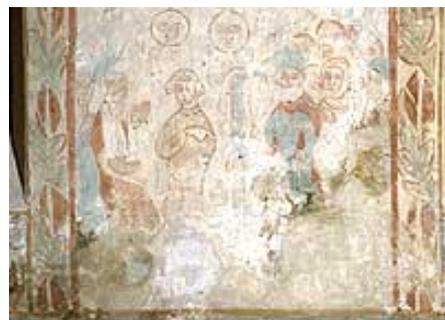
Mortar repairs were clearly visible in UV lighting. Various shades of dark blue marked repairs from the different historical restorations. It seemed that the lesser degree of carbonation (more recent repairs) was represented by a deeper blue colour. An accumulation of salt efflorescence around the mortar repairs (visible as white fluorescence) demonstrates the non-porous character of the mortar used in the earlier periods. White fluorescence also marks areas where polyvinyl acetate used as a consolidating medium dripped down the surface of the painting.

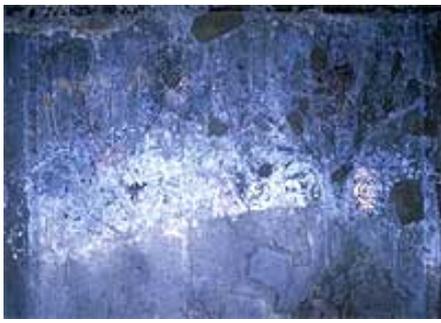
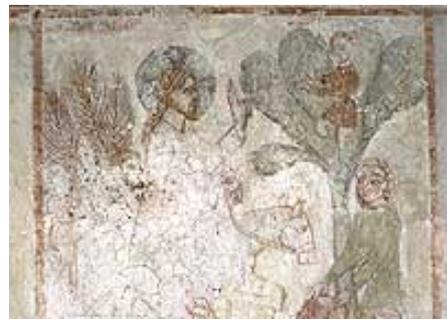
A wide band of white fluorescence on the upper scene on the east wall shows the height of the vaulting that was erected around 1500. The fluorescence is probably the result of a denser presence of carbonates in this area, as mortar used in the construction of the vault was in direct contact with the painting in this area.
