Analysis, Protection and Preservation of Medieval Wallpaintings.

A Raphael-Project financed by the European commission is developing innovative preservation strategies combined with an extensive information network.

Analysis, Protection, and Preservation of Medieval Wallpaintings

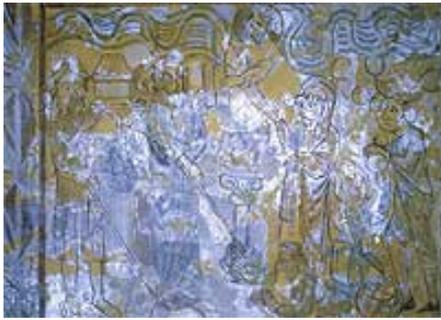
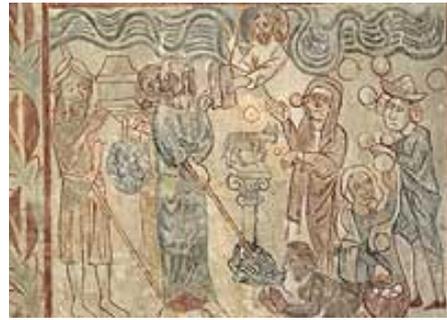
Examination of the transferred scenes in UV lighting also gave interesting results. Very strong mustard-coloured fluorescence was observed on the older transfers mounted on chipboards. Although it is difficult to pinpoint the source of this phenomenon, it is probably connected either to the polyvinyl acetate used in the backing, but also seems to stem from the heavy retouching on the front of the transfer. White fluorescence on the older transfers is probably a result of the large amount of salts that were transferred together with the paint layer, and demonstrates that these were not removed when water was applied to the front when washing the facing off the transfer. Also seen were patches of darker blue, denoting areas where mortar repairs were carried out in earlier periods.

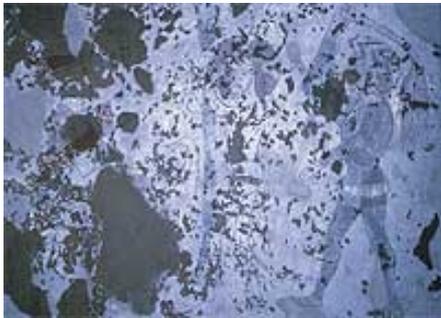
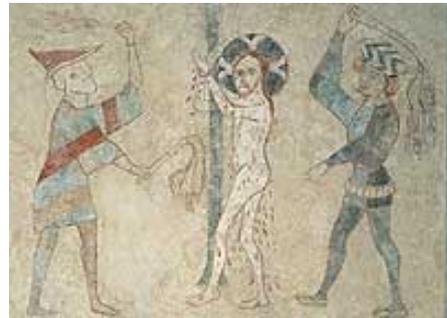
The newer transfers mounted on honeycomb plates did not display the strong yellow fluorescence visible on the older transfers, despite the fact that polyvinyl acetate was also used here. It was, however, mixed with other glues and fillers, which might explain the totally different result. The lacunas in the paint layer did not display any fluorescence, appearing dark blue. White fluorescence was also visible, though to a lesser degree than on the older transfers, as were the medium blue spots marking the presence of mortar repairs from earlier periods.

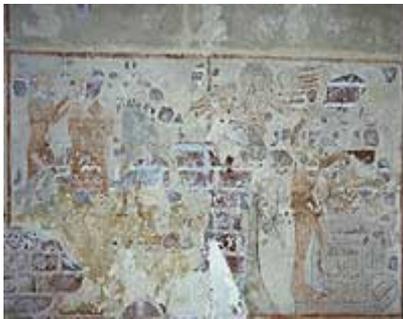
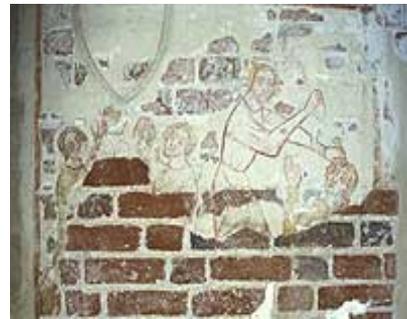
Prior to the most recent re-restoration of the decoration in Tirsted Church about 50% of the surface in the chancel was covered by plaster repairs from earlier restorations. All of these repairs had smooth surfaces, and although no cement was found in them, they were much harder than the surrounding original plaster. Although the salt analysis of the various plasters showed that the repairs were also contaminated by salts, the content was small compared to the amount of salts found in the original plaster. The scientific data was corroborated by visual examination in normal and UV light, where it was clear that the salt damage was concentrated in the areas of the original plaster directly adjacent to the hard plaster from the repairs. This phenomenon was due to the fact that the migration of salts is easier in the more porous structure of the original plaster.

Despite the fact that the majority of the reconstructions from earlier treatments would be destroyed with the removal of all the smooth and hard repairs, this was decided in order to create a more homogenous interior surface. (All reconstructed areas were traced on plastic foil before they were hammered down). Some of the scenes lost 50% of their content. But the south wall presented the most drastic situation: when all of the scenes that were transferred to chipboards or honeycomb plates were removed, only a little portion of the surface, where four scenes were located in the south-west side, remained on the wall .

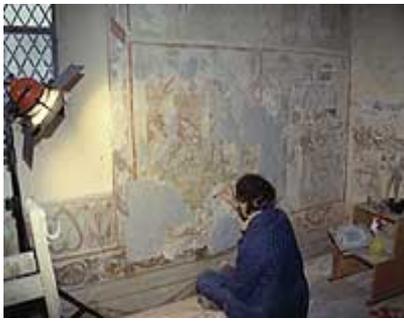
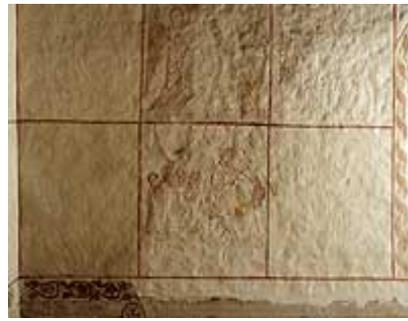
Although this decision was taken primarily due to the moisture and salt problems, the execution of new plaster repairs also gave an opportunity to improve the aesthetic presentation of these surfaces. The original rendering was not smooth at all, and all of the flat repairs were, therefore, visually incompatible with the undulating surface. The new repair mortar consisted of one part six-year slaked lime putty and 3 parts fine sand (grain size: 0.0 – 2.0 mm). One part powdered quartz was added to every 12 parts mortar. Although the addition of such fine material rendered the mortar slightly less porous, it improved the plasticity and workability of the mortar enabling the recreation of the original surface texture in the repair.

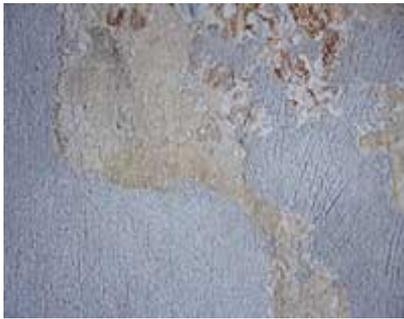
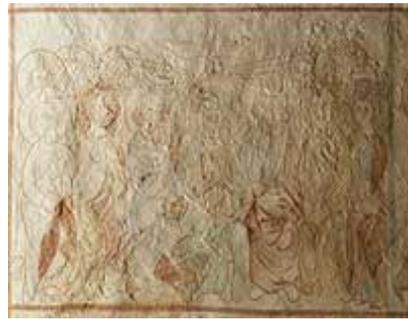
The mortar was applied in an excess quantity, and after it had set (30 min. to several hours depending on the area of the repair) the surface was cut with a spatula and sculpted to imitate the relief of the original rendering. The areas which appeared too grainy were pressed down, but not polished with the trowel. Finally, lines were incised in the repairs in order to imitate the texture of the brushstrokes in the lime ground layer. The incisions, of course, only gave an approximation of the visual effect of the brushwork, as they created an impression in the plaster, whereas the brushwork created a relief. Nevertheless, viewed at a distance, this effect recreated the textural liveliness of the original surface.

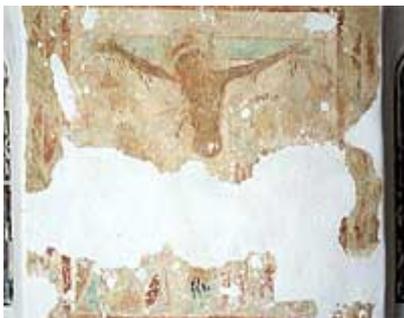
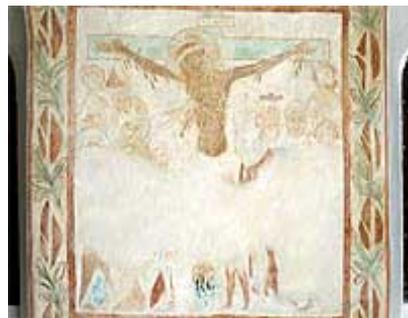
The final surface treatment of the plaster repairs consisted of the application of several layers of limewash, which formed the ground on which the reconstructions and retouching could be carried out. The initial limewash contained an aggregate (1 part powdered quartz for every 2 parts lime putty, mixed with 12 parts water) in order to even out the graininess of the repairs. This was followed by two coats of limewash, and, finally, a layer of pigmented limewash, which was toned to match the warm-coloured original limewash.

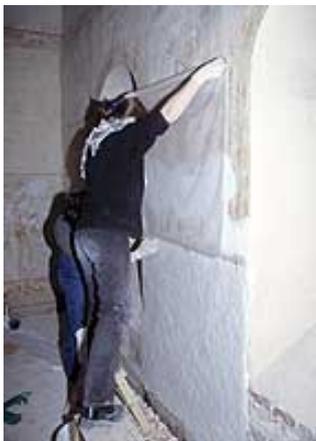
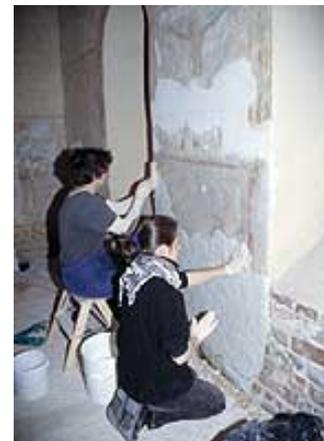
The salt reduction was carried out with paper pulp (Arbocel BWW 40) and demineralised water. The principle behind salt reduction with multiple compresses is that water from the compress enters into the pores of the paint layer and rendering directly below it, and dissolves the salts. The salt solution then migrates to the surface as the compress starts to dry, and is removed together with the compress. Direct contact between the paint layer and the paper pulp is prevented by a thin layer of tissue, which is fastened to the wall with water before applying the compress.

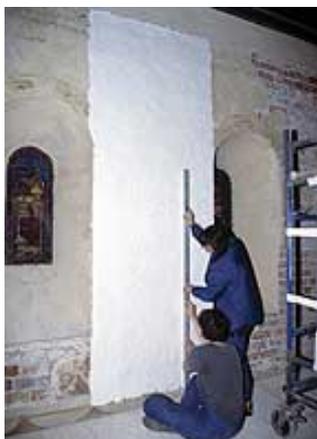
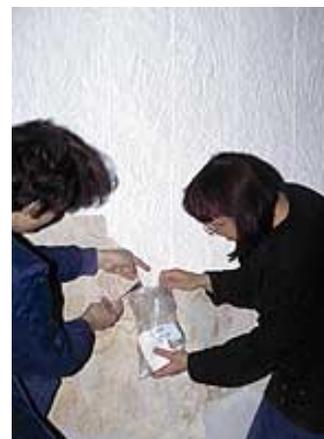
For every 5 kg of paper pulp, 27 - 28 litres of demineralised water were used. A portion of this size could cover the area of about 4 square metres. The compress was not allowed to dry out completely before it was removed, in order to prevent shrinkage and risk of detachment of the paint layer. The tissue separating the paint layer from the compress facilitated its removal. Otherwise bits of paper pulp would be lodged in the tiny pits and holes in the surface.

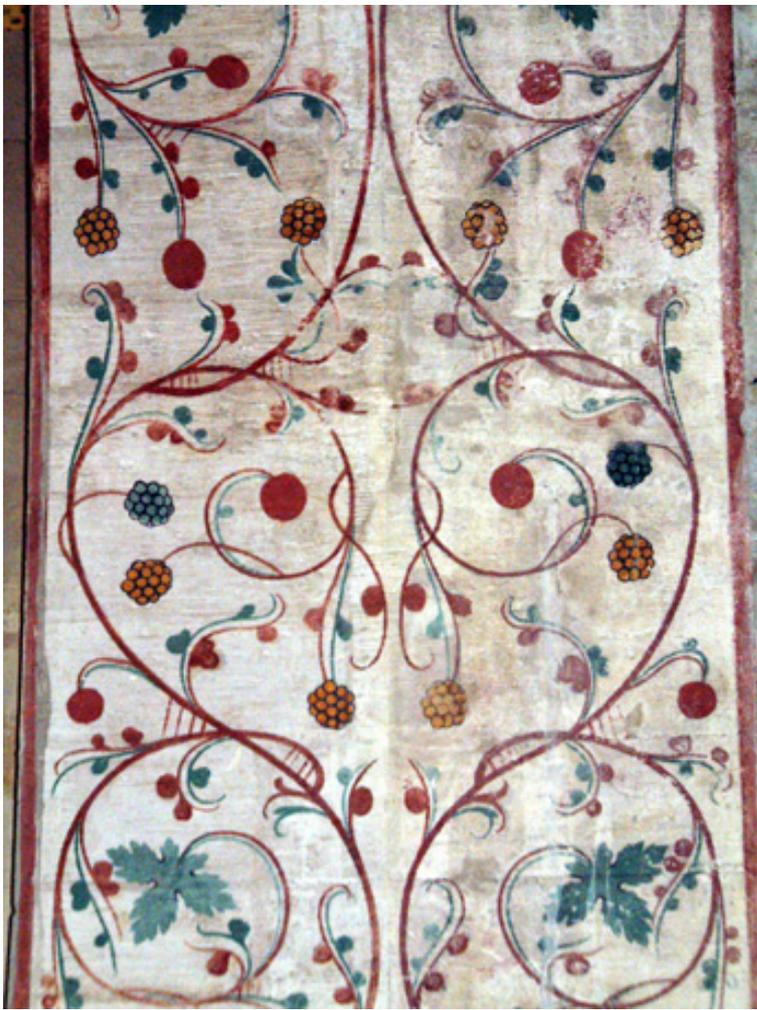
Another painting preserved at the formeret reveal is a floral design created after 1887, possibly complementing the older painting from the 16th century. This lime painting depicts stylized red and green foliage with ochre-coloured fruit.

Painting on the formeret reveal.

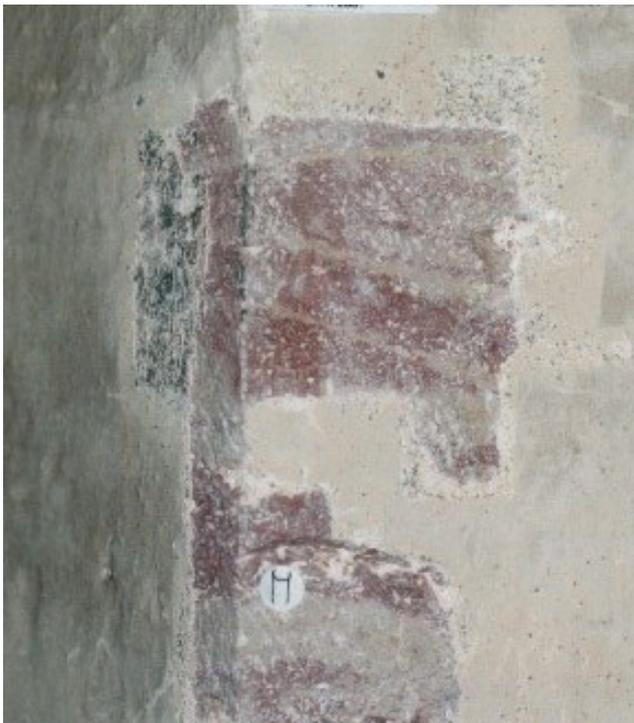
At the painted window ashlar of the clerestory and the ashlar of the arcade in the western vault bay remnants of red (*Carput mortuum*) marbled streaks could be found which can be dated back to the time when the vault of the main building was erected.

*Uncovered marbled streaks on the ashlar of the western clerestory window.
Foto: K. Heiling.*

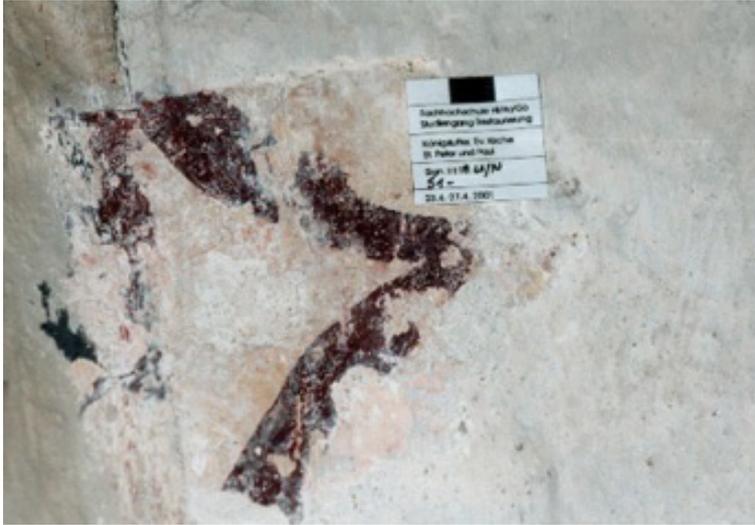
*Uncovered foliage painting in the vault of the northern lateral nave.
Foto: K. Heiling.*

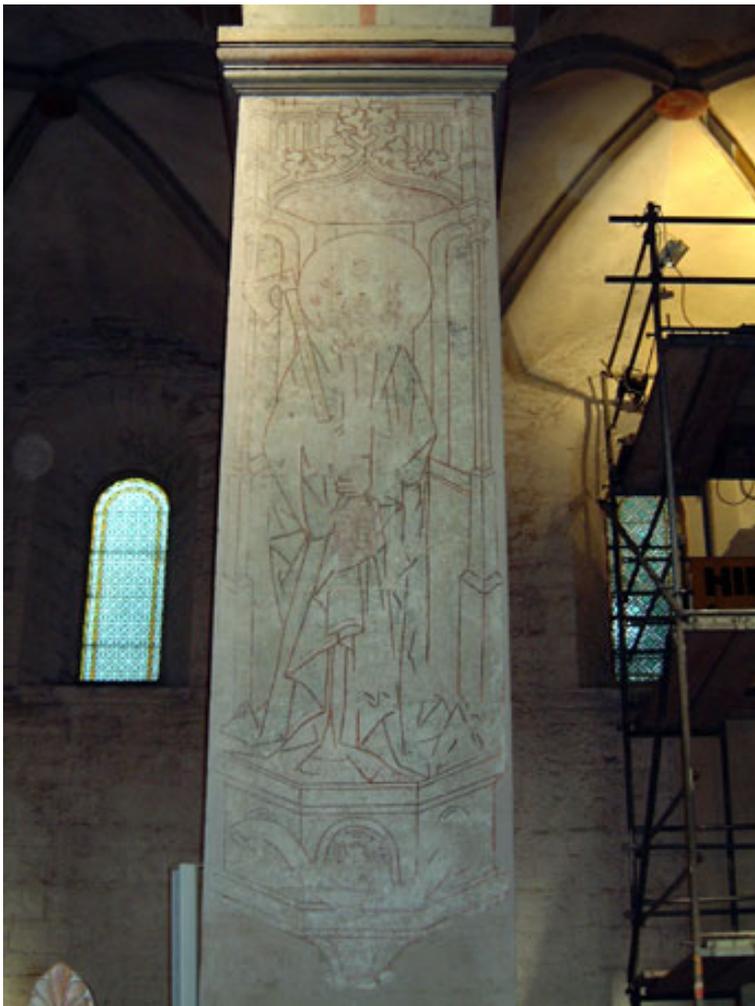
Fragments showing saints with painted pedestals and canopies (around 1500) were uncovered in the 19th century on two pillars of the nave. These paintings show red/black outlines which have been heavily traced and overpainted. Parts of the garment reveal green pigments. The same date can probably be assigned to the remnants of a red foliage design on white lime wash which are located on the north wall of the northern lateral nave, as well as to fragments of a red foliage painting which were found on the vault web of the lateral naves. The ribs and formerets were likely painted in a corresponding red. Floral motifs in red and green could be found on the keystones of the lateral nave vaults.

Pillar showing the fragmentary painting of a saint.

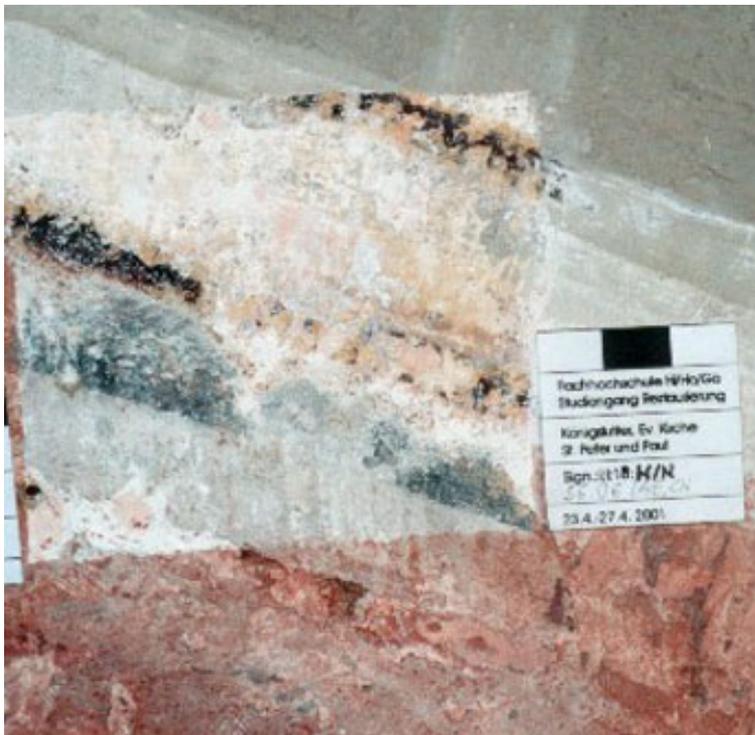
In the main building fragments of a grey ashlar painting with black outlines (17th century?) could be found on the square stones of the western arcade. Correspondingly the ribs and formerets in the lateral naves show numerous grey and black (blackened pigments?) painting fragments.

Uncovered fragments on the arcade.

The grey ashlar painting with black joints was applied directly onto the stone.

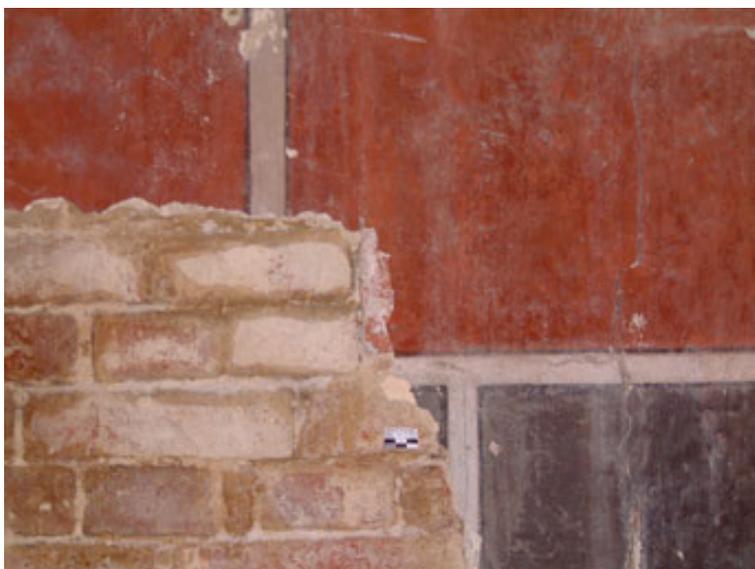
The ashlar painting on the lower wall regions, created by Essenwein in the 19th century which can still be seen in the eastern part of the Kaiserdom, recreates an older ashlar painting in form and colour. Not dated exactly as yet this older painting was uncovered in the course of Essenwein's actions and incorporated into his conception. Fragments from this period could be found on the south wall of the southern transept and lateral nave as well as on the north wall near the lion portal.

At the edges of the uncovered area fragments of an older ashlar painting can be found.

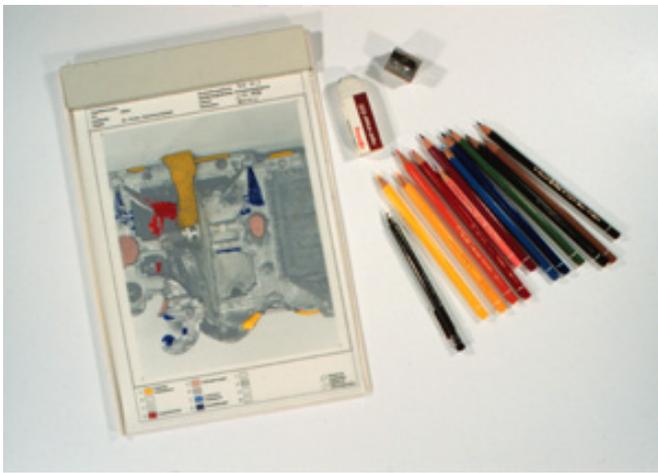
Materials for manual mapping. Base map and overlay are fixed congruently using a drawing board. The corners of the photographic base map are copied as reference marks on all overlays.

Each person will require a minimum set of drawing tools, including a fine, hard black-lead pencil; eraser; pencil sharpener; A4 drawing board; and an appropriate selection of standard coloured pencils for the phenomena likely to be encountered. The use of Schwan *Stabilo* pencils is specified in the NLD mapping system, based on the RAL (German Institute for Quality Assurance and Labelling) colour palette. Pencils must be ordered separately, because a complete set of the selected colours is not available, and it is important to have the coloured pencils available in good time.

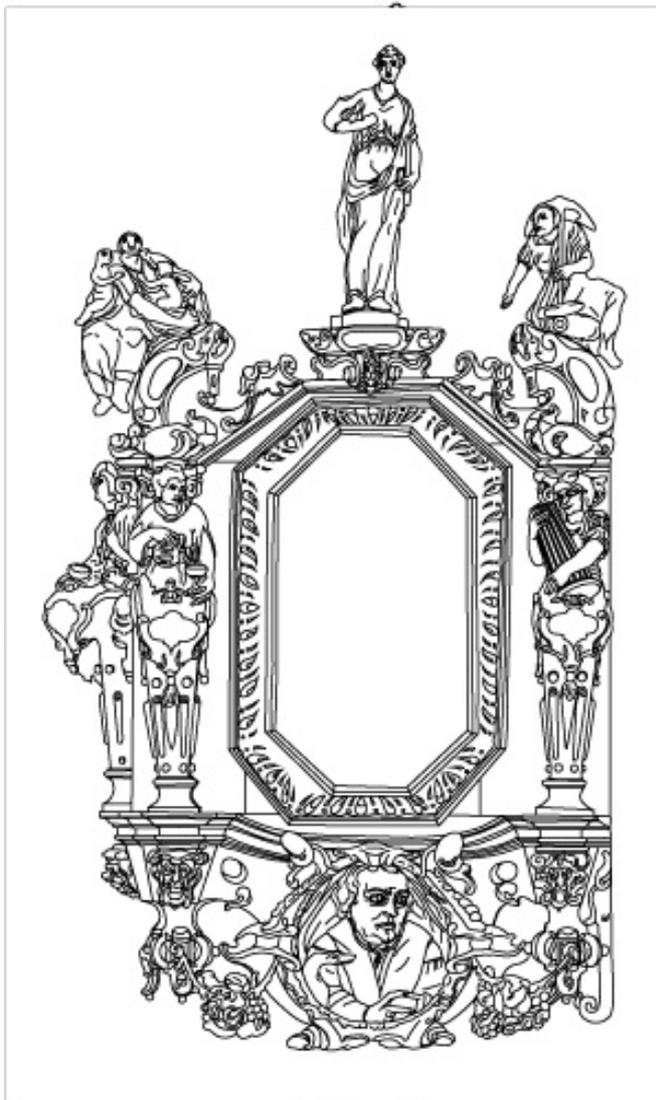
Germany, Stadland-Rodenkirchen, Protestant church, altarpiece, left stringboard. The quality of this line drawing produced via CAD meets the standards of a manually produced drawing.

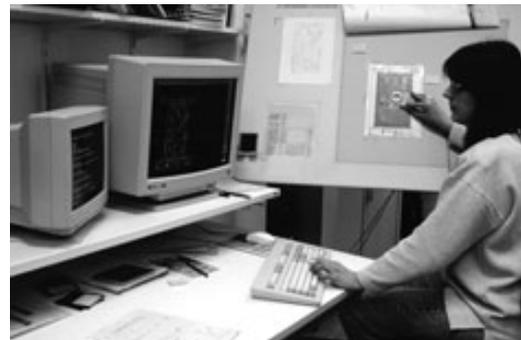
CAD workstation with A1 digitizer for introducing large maps.

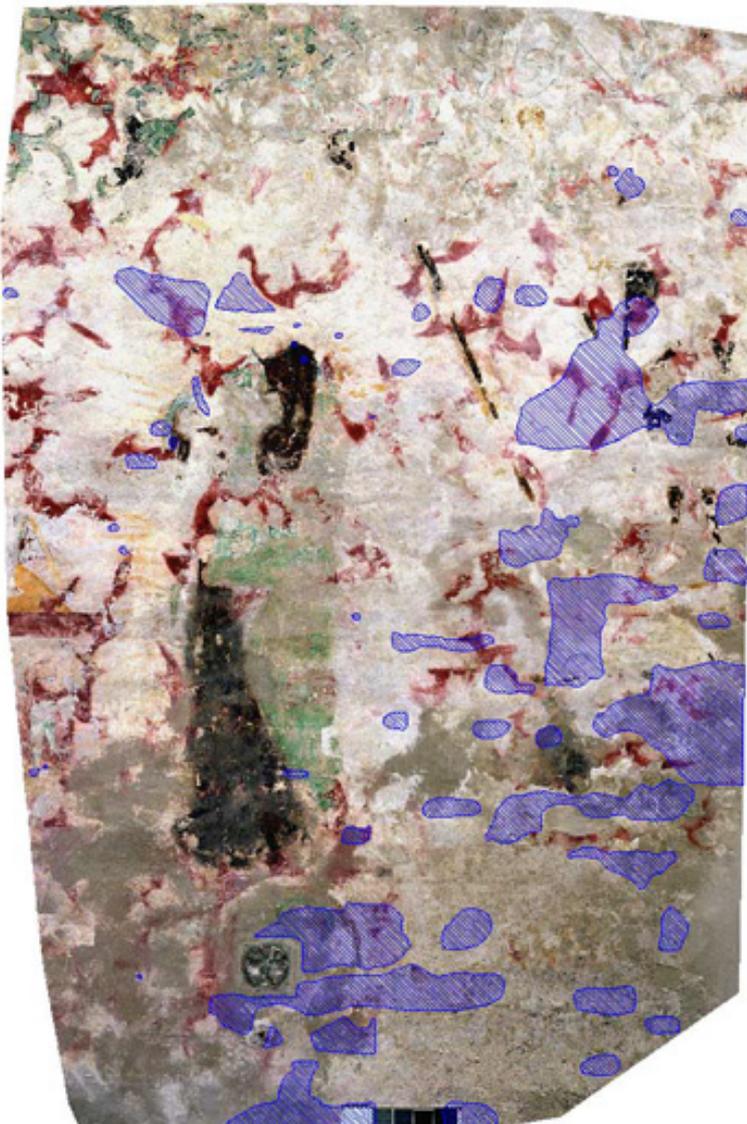
Schadenskartierung

- Malereiverlust
- Putzverlust
- schollenförmige Abplatzungen
- Verpressungsläufer und Schleier
- pudernde Malerei
- Salzpuder
- drückende Salze
- Salzausblühungen
- Salzkruste
- Salzpusteln
- Risse

Germany, Königsutter, Stiftskirche. Historicist wallpaintings in the northern transept. CAD-mapping of damage phenomena on the base of a rectified black&white image. Test conservation area on the north wall (1998) is marked in yellow. (Deutsches Bergbau-Museum Bochum, Ochsenfarth Restaurierungen Paderborn)
